Metallurgical Examination of a Failed AH-64D Pilot Cyclic Stick (Part Number 7-511512001-3)

ARL-TR-3272

August 2004

**Victor Champagne and Scott Grendahl
Weapons and Materials Research Directorate, ARL**

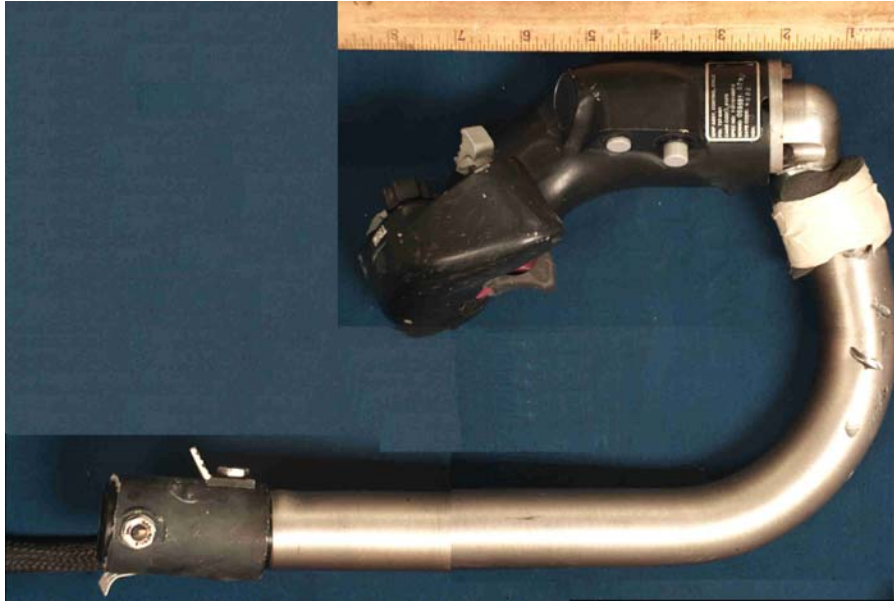
The pilot cyclic stick was broken into two separate pieces at the weld, attaching the tubular portion to the elbow (figure 1). In figure 1, the fracture surfaces had been covered with foam and taped for protection. Figures 2 and 3 show enlargements of the fractured weld. The fracture occurred along the entire circumference of the weld in the center of the weld bead. It was quite evident that the weld did not have complete penetration in most areas, as evidenced by the relatively smooth surface finish on the elbow and the fact that the elbow did not fracture.

Figure 1. The fractured AH-64D pilot cyclic stick as received by ARL.

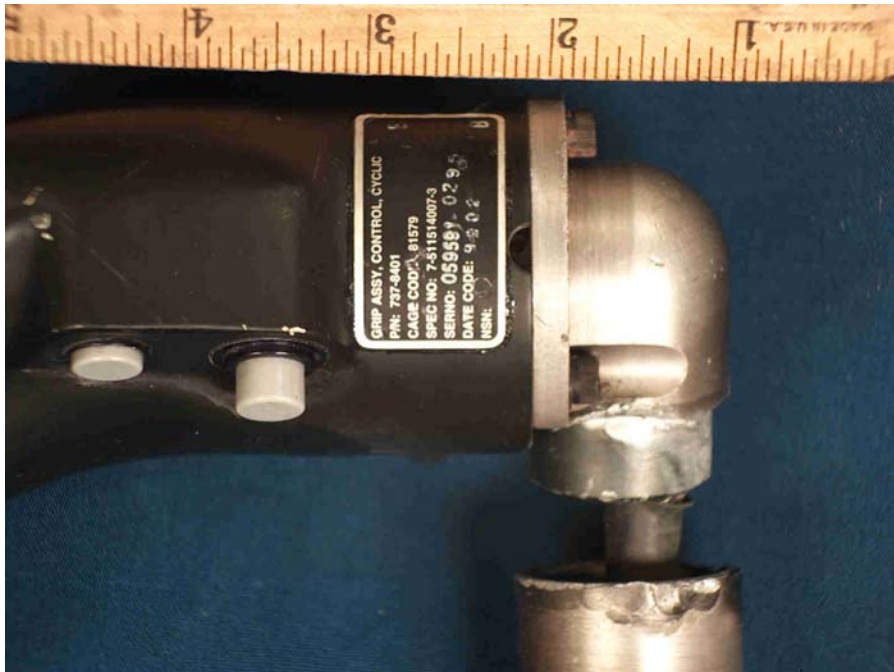
Figure 2. Enlargement of the fracture area on the pilot stick.

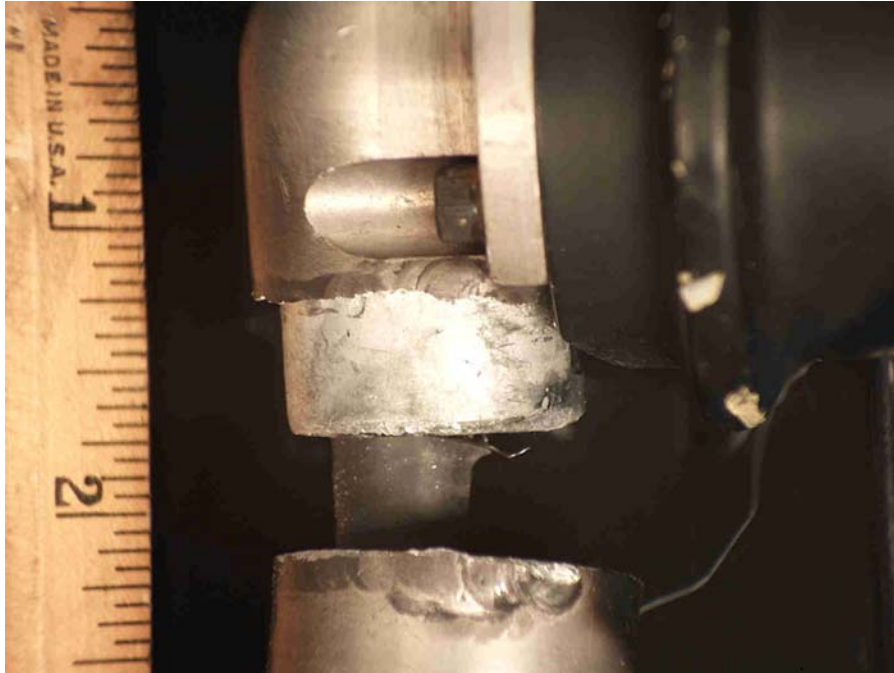
Figure 3. Detail of the pilot stick fractured area.

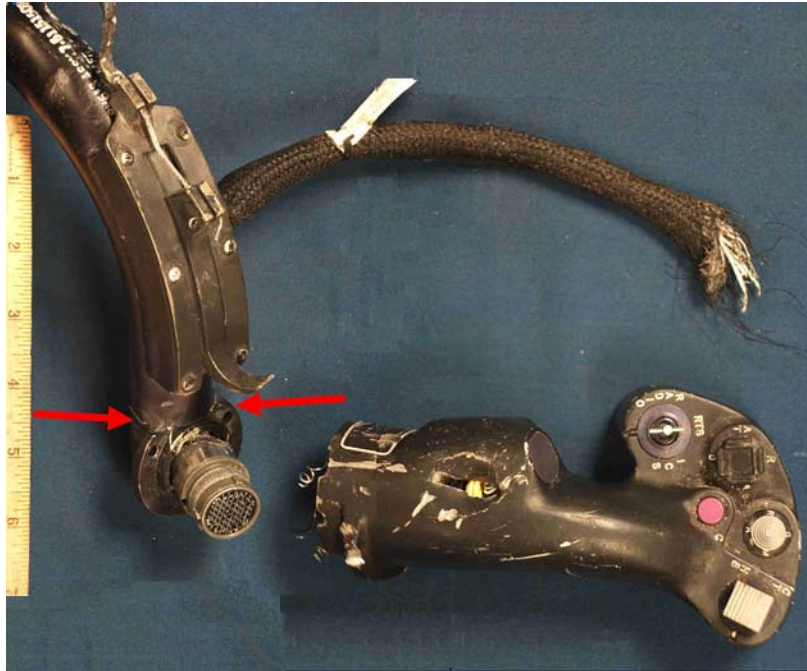
The copilot cyclic stick was cracked in the same area but did not break into two pieces (figure 4). The bolts that mount the grip to the stick were removed prior to the photograph being taken. Arrows indicate the area of concern in figure 4. Both sticks sustained mishap damage. The copilot stick contained considerably more damage, such that areas of the aluminum tube as well the section containing the control buttons, were dented, gouged, and/or bent, indicative of severe impact loading. However, the copilot cyclic stick, although cracked, was still intact and would most likely require a mechanical testing machine to properly separate the two fracture halves for subsequent examination (figure 5). The important point was that the fractured copilot stick could not easily be broken the rest of the way. Subsequently, the wiring assembly, which ran through the tubular section, was removed, separating the “tube” fracture half from that of the “elbow” fracture half.

Figure 4. The fractured AH-64D copilot cyclic stick as received by ARL.

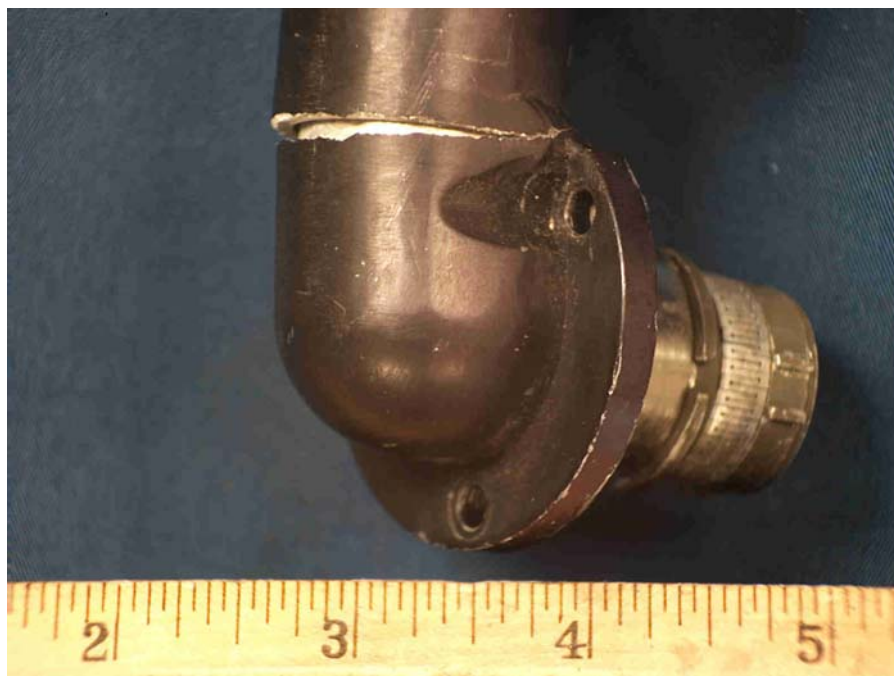
Figure 5. Detail of the copilot stick crack at the elbow to tube weld.

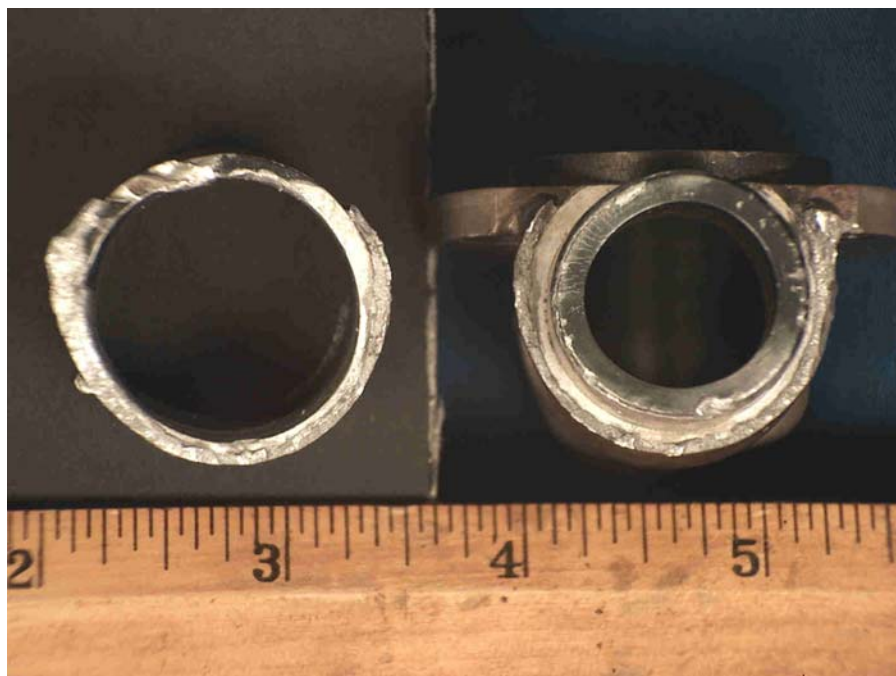
Figure 6 shows the tube fracture and the elbow fracture halves, respectively. The lack of penetration appeared as areas without fracture topography, where the as-formed/machined surfaces of the tube and the elbow were clearly discernible. Significant portions of the joint interface also sustained damage and appeared as bright patches without reconcilable topography. Figures 7–9 are enlargements of the weld fracture, showing the lack of penetration and large gas voids. The tube wall thickness was ~ 0.095 in and was used along with the surface morphology characteristics of the fracture to determine weld penetration.

Figure 6. The fracture halves of the pilot cyclic stick.

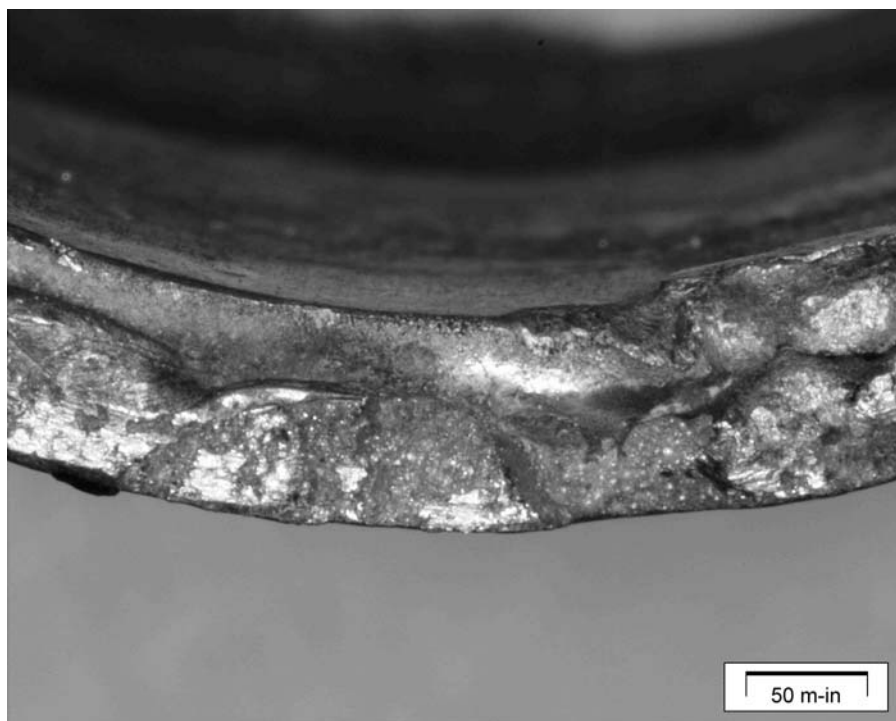
Figure 7. Lack of penetration observed on the tube side fracture half.

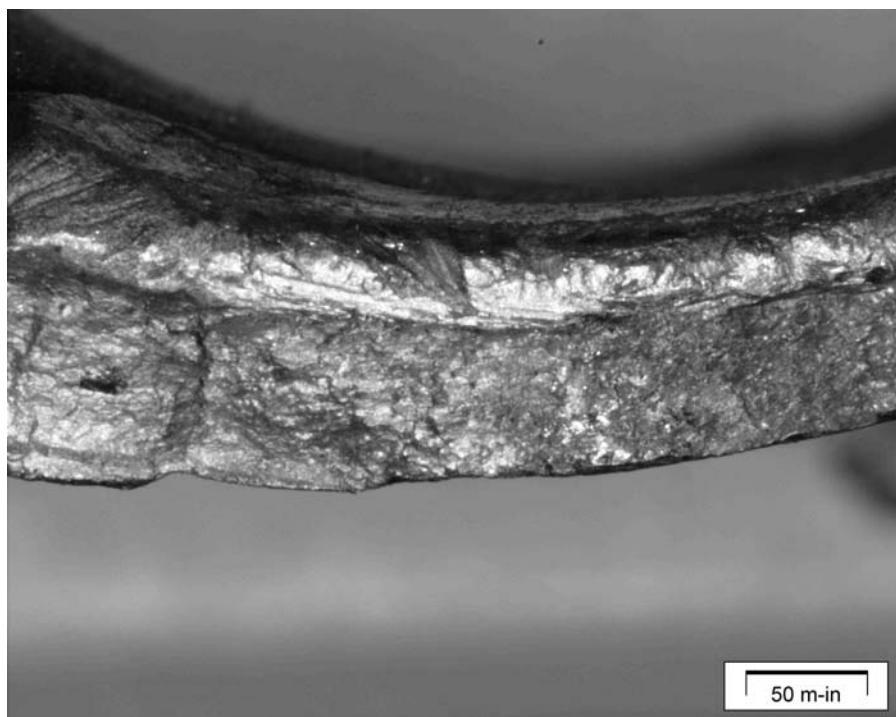
Figure 8. Lack of penetration on the tube side at location G on the drawing.

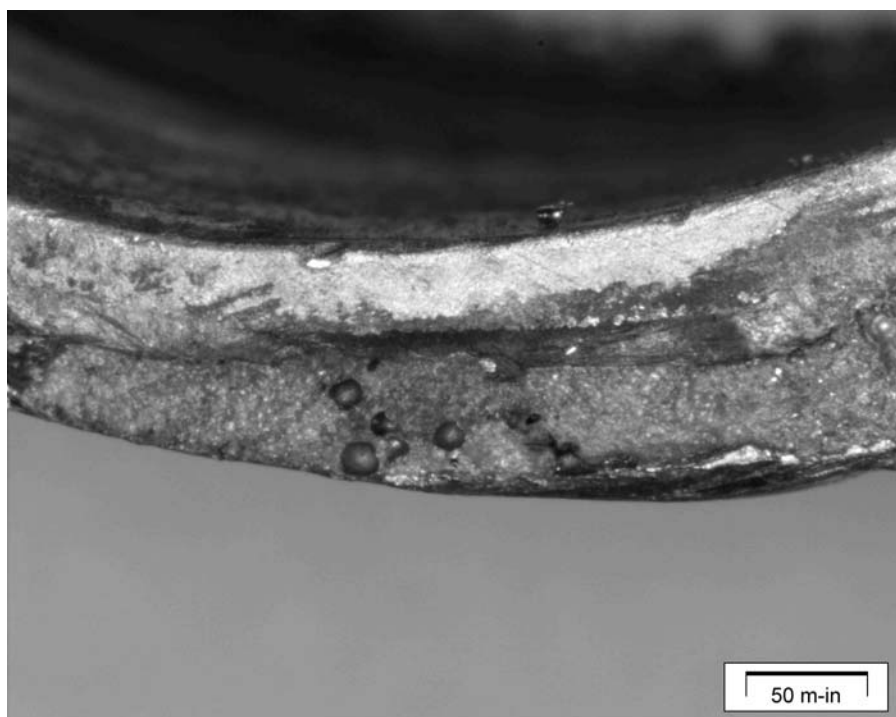
Figure 9. Lack of penetration on the tube side at location F on the drawing.

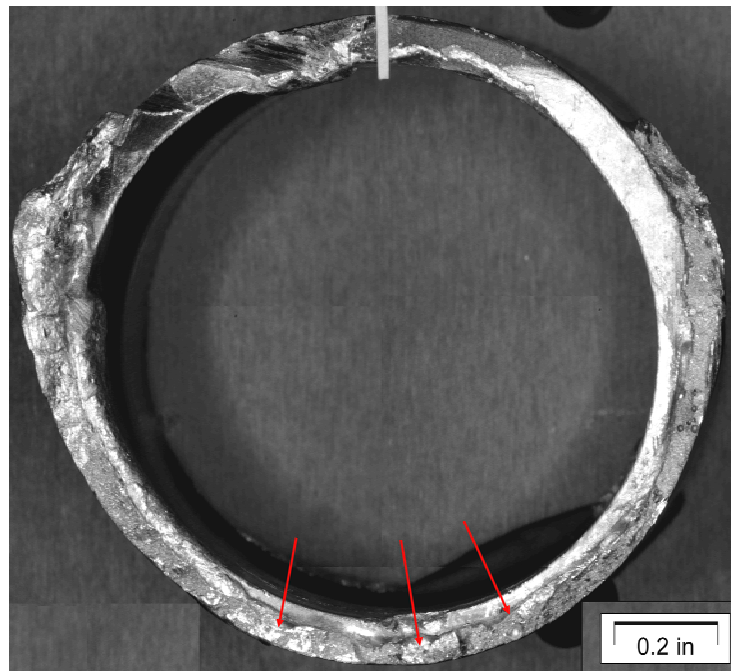
Figure 10 is a montage of the entire tube weld fracture from which penetration calculations were determined. The cross-sectional area of the welded region was ~40%, as determined by quantitative image analysis. This value was obtained by taking the ratio of the calculated areas between the welded fracture surface and what should have been welded according to the manufacturer's engineering drawing. The area coincides with the tube thickness mating with the elbow below the top of the flange. Figure 11 shows the portion of the tube that should have been welded, while figure 12 depicts the areas left unwelded. The calculated percentage of welded material can be used with the tube thickness to estimate the loading required to fracture the assembly.

Figure 10. Montage of the fracture surface of the pilot cyclic stick.

The failure originated at the root of the weld where there existed incomplete penetration coupled with localized flaws. Arrows in figures 10–12 depict these areas. Figures 13–16 show all three areas in greater detail on the elbow fracture half.

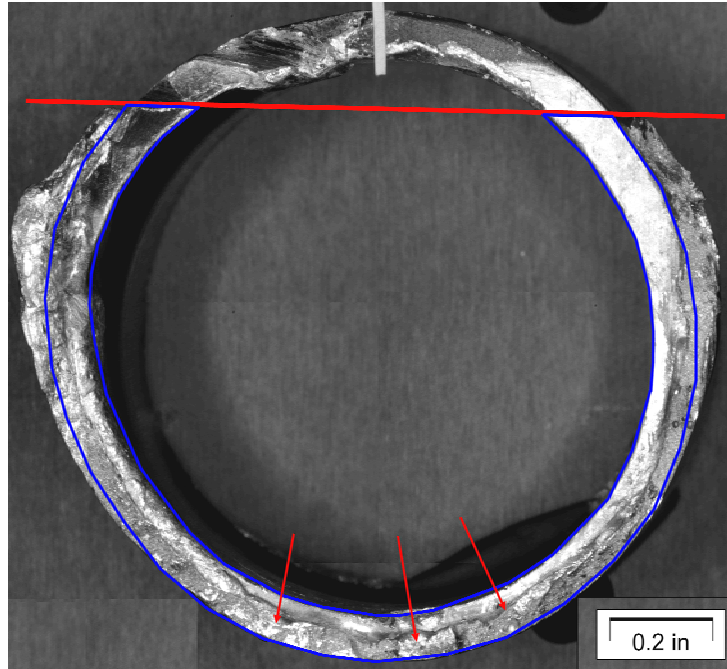
Figure 11. Montage from figure 10 depicting the area that should be welded.

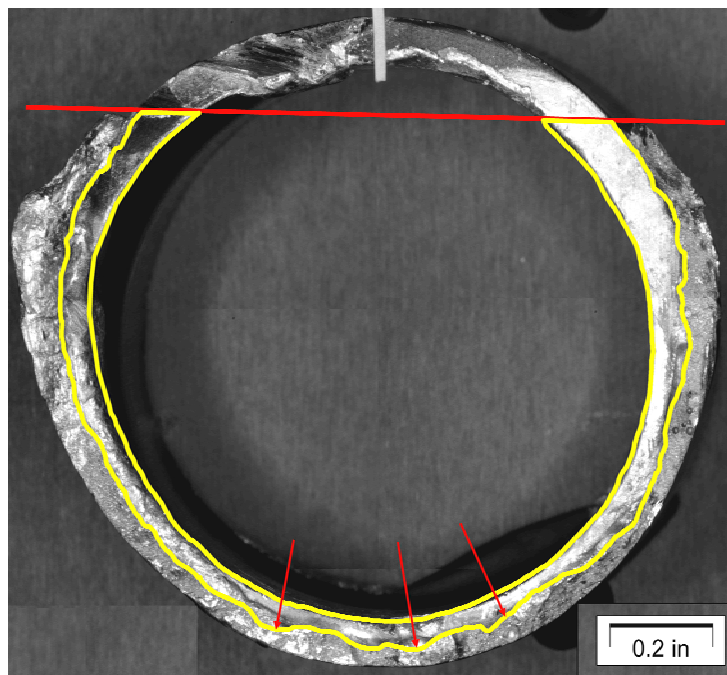
Figure 12. Montage from figure 10 depicting the area that was not welded.

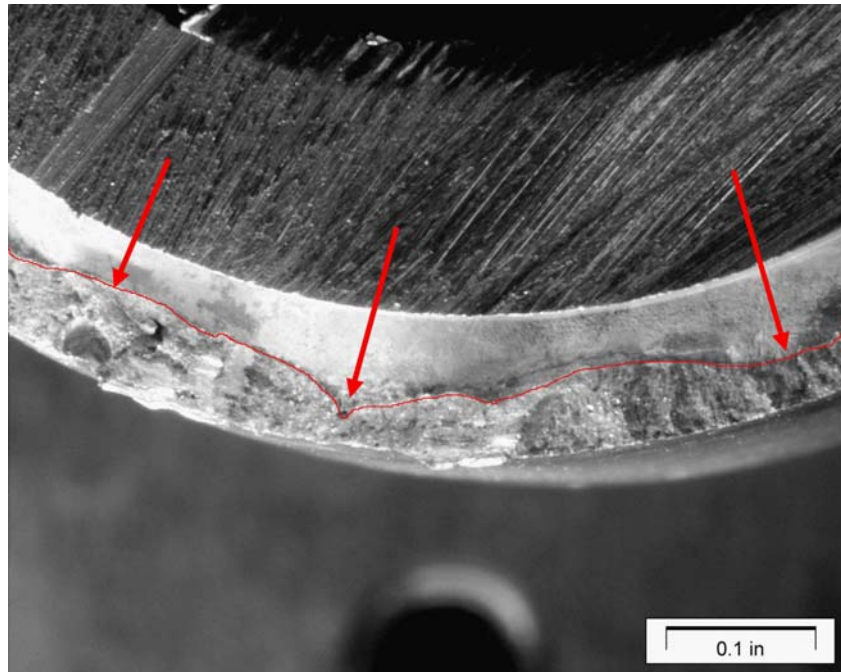
Figure 13. Elbow side fracture half depicting failure origins.

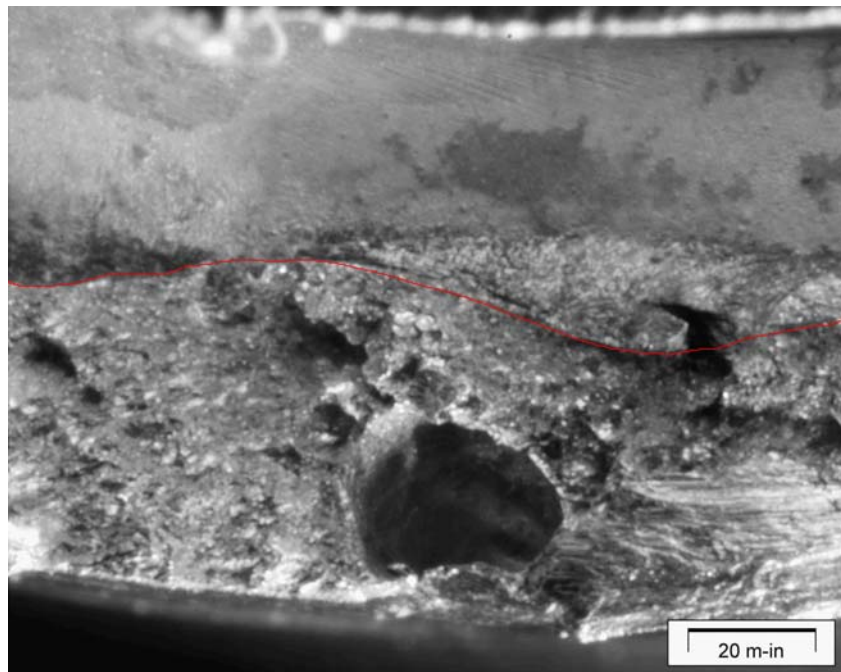
Figure 14. Elbow side fracture half depicting large gas void failure origin, from left side of figure 13.

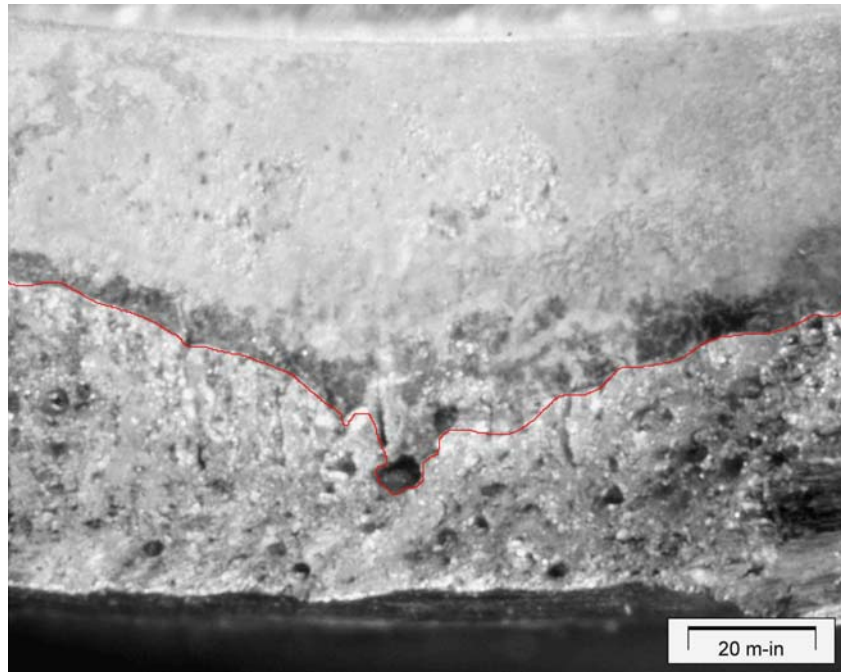
Figure 15. Elbow side fracture half depicting failure origin from cracks and a gas void at the root of the weld, from middle of figure 13.

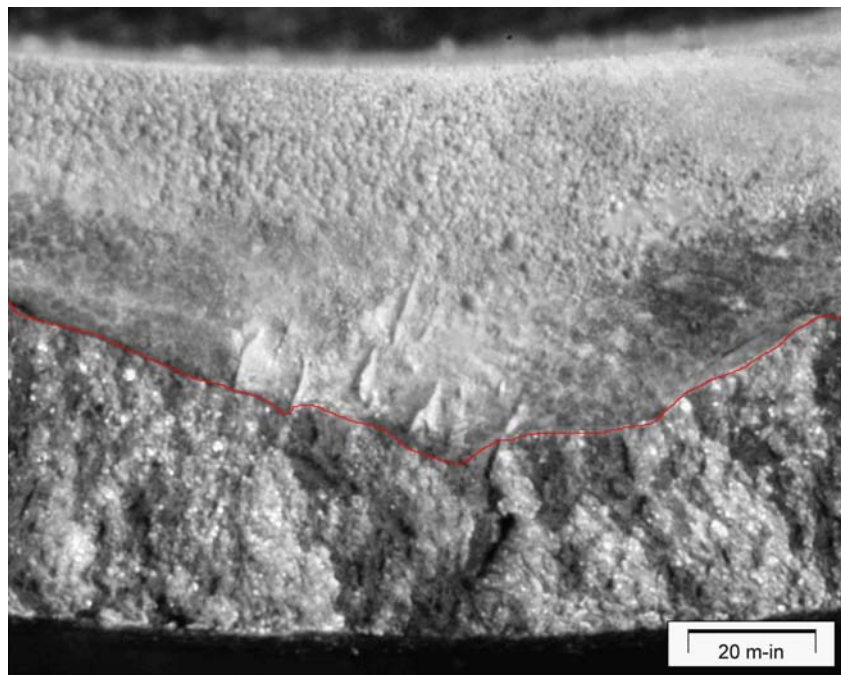
Figure 16. Elbow side fracture half depicting failure origin from large cracks at weld root, from right of figure 13.

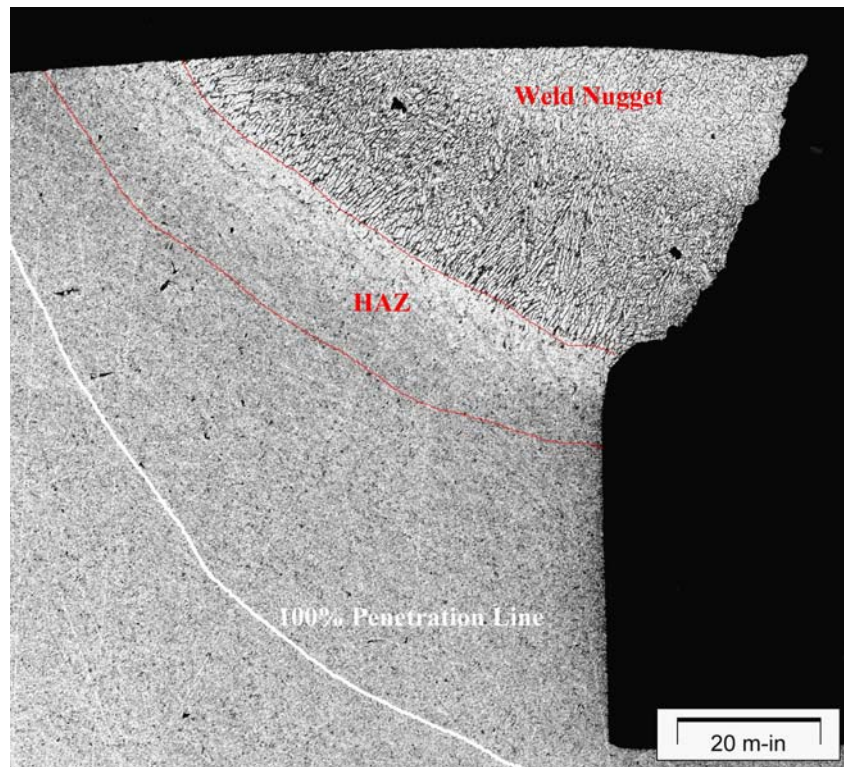
A cross section of material was taken through the fractured weld on the “tube side” of the fracture as well as on the “elbow side” of the fracture. Both samples were mounted and metallographically prepared for examination. Keller’s reagent was used for etching. Figure 17 is an optical micrograph of the elbow fracture showing the lack of penetration of the weld. To illustrate a weld with 100% penetration, an outline of such a weld (drawn in white) was added to figure 17. The weld bead contained an interdendritic network of aluminum-silicon eutectic (black) and dark etching, Al-Mg₂Si eutectic between the grains in the heat-affected zone. Figure 18 is an optical micrograph of a cross-section of the tube side of the fractured weld, which did not contain any of the elbow material, also indicating a lack of penetration. Porosity was observed within the weld. Figure 19 represents a micrograph of the tube base material showing a matrix of aluminum solid solution containing particles of Mg₂Si (black).

Figure 17. Elbow side cross section through the weld; the white line depicts what would be a 100% penetration weld.

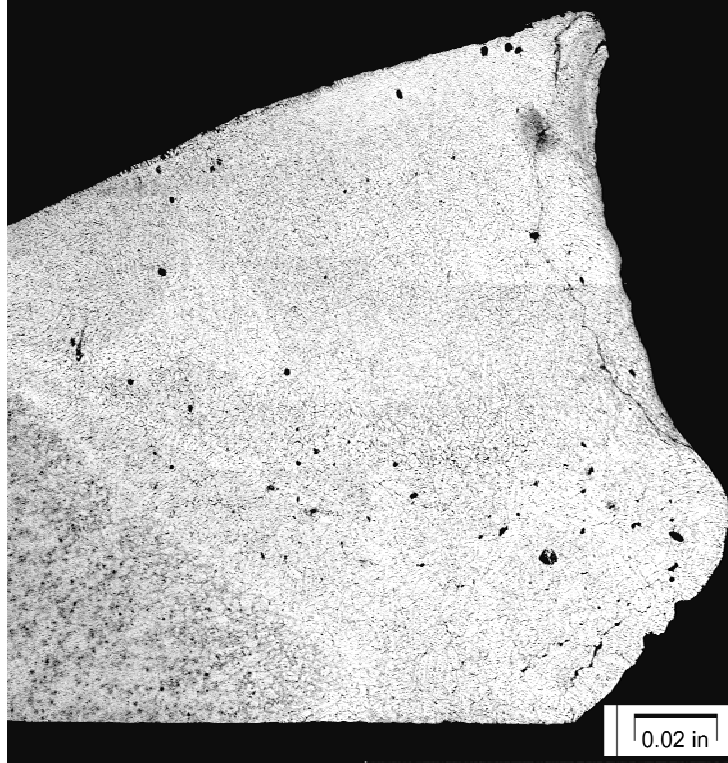
Figure 18. Tube side cross section through the weld.

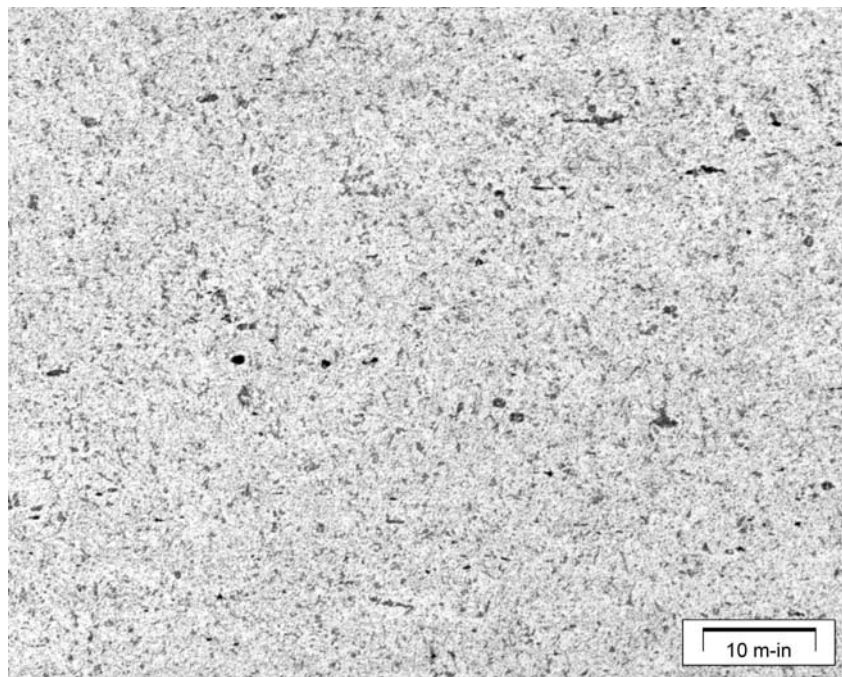
Figure 19. Tube side cross section of base material.

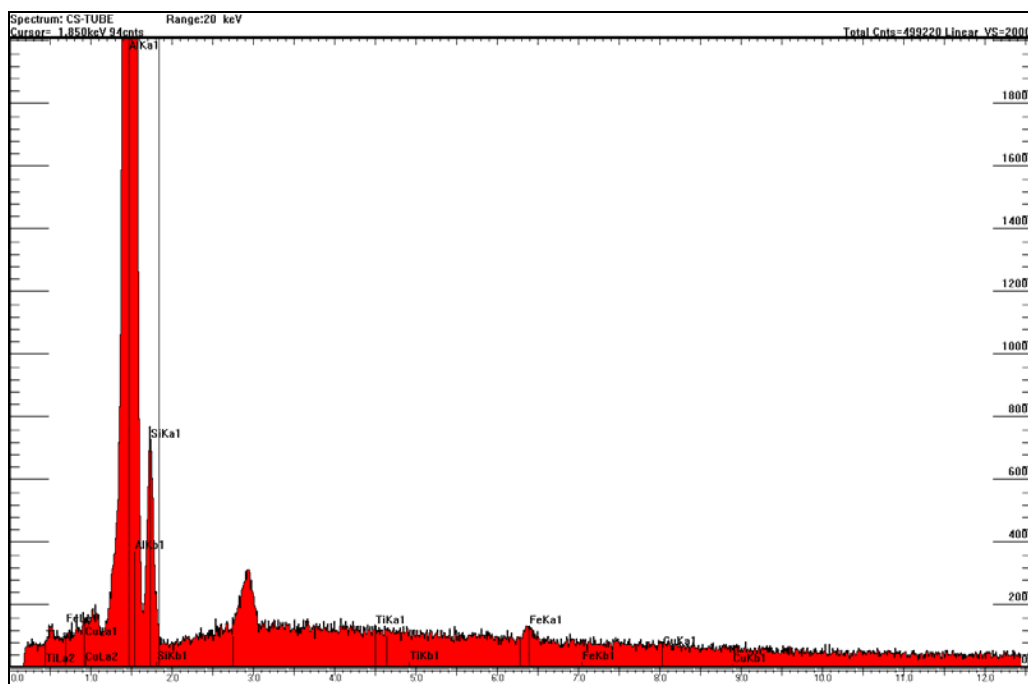
The chemical composition of the weld bead was initially determined by quantitative energy dispersing spectroscopy (EDS), within the scanning electron microscope. This method was chosen to obtain relative chemical composition quickly in lieu of wet chemistry techniques to verify the weld rod material. It was not meant to provide absolute values of chemical composition. The differences in the silicon and copper content between the two welding rods were the distinguishing elements used as a basis for comparison. The small concentrations of manganese, magnesium, and zinc did not yield an appreciable peak and therefore did not factor into the overall weight-percentage calculation. Samples of the two possible weld rod materials, AMS 4190 (ER4043) and AMS 4189 (ER4643), were obtained and analyzed to calibrate the EDS system. The spectra obtained are shown in figures 20 and 21. A section of the weld bead on the elbow fitting was polished with 15- μ m diamond paste, to remove surface contamination, in preparation for EDS analysis. The spectrum of the weld bead compared favorably to that of ER4643, as figure 22 reveals. Table 5 lists the corresponding numerical values of these EDS analyses.

Figure 22. EDS spectrum for the filler metal on the welded pilot stick.

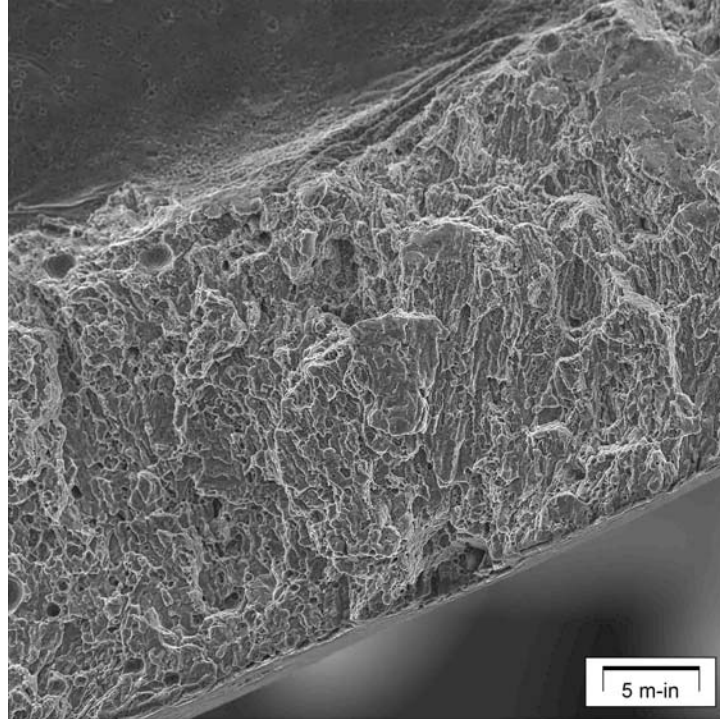
SEM examination of the fracture surfaces did not reveal any evidence of fatigue, such as beach marks, fatigue striations or a region consistent with an “older” fracture surface. No type of crack arrest marks were found anywhere on the fracture, suggesting that the entire fracture occurred all at once. Additional information substantiating this position was the predominately dimpled fracture morphology, which is indicative of overload conditions (figure 23). At times, these dimples demonstrated directionality, as in figure 24, but only in the late stages of fracture typical of sheared material. There also existed some areas where quasi-cleavage fracture was present (figure 25).

Figure 23. SEM fractograph showing the morphology predominant on the cyclic stick.

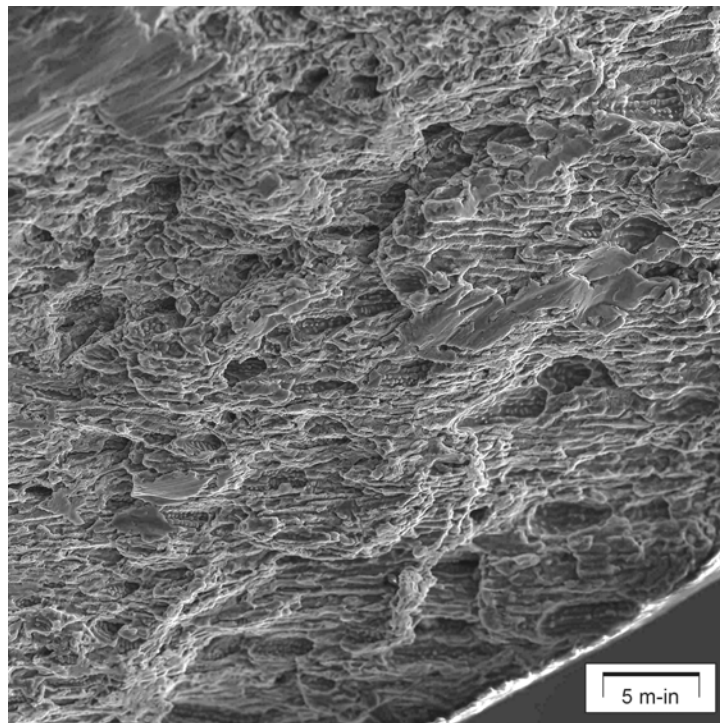
Figure 24. SEM fractograph showing dimpled morphology with directionality.

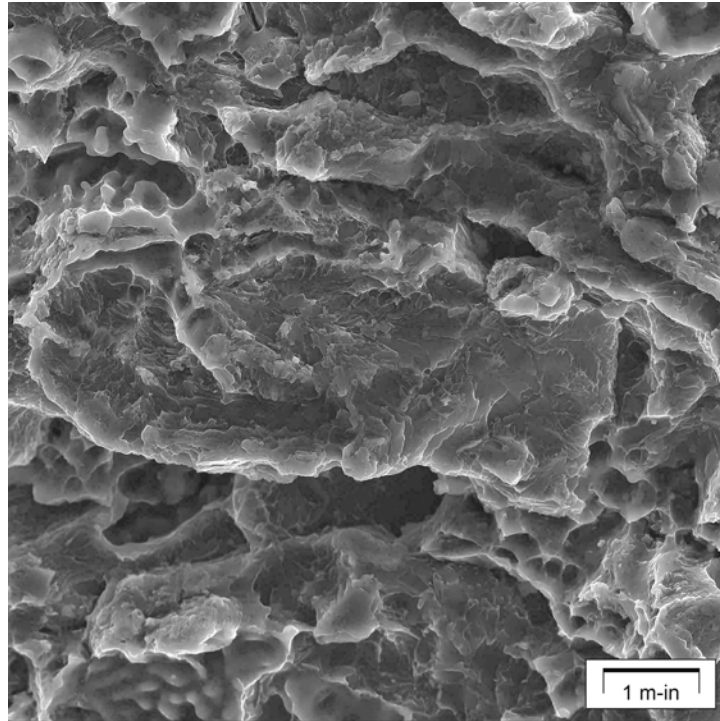
Figure 25. SEM fractograph showing quasi-cleavage morphology.

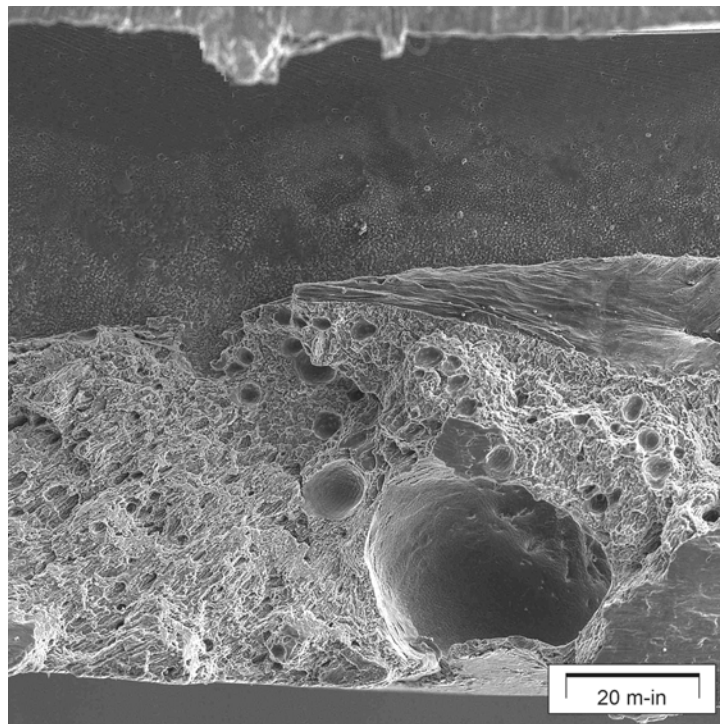
Figure 26. SEM fractograph showing fracture origin from figure 14.

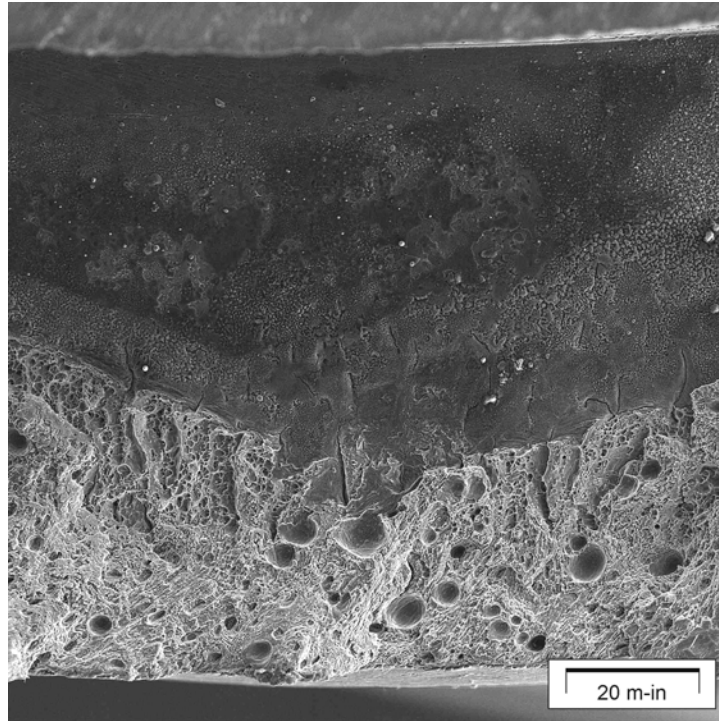
Figure 27. SEM fractograph showing fracture origin from figure 15.

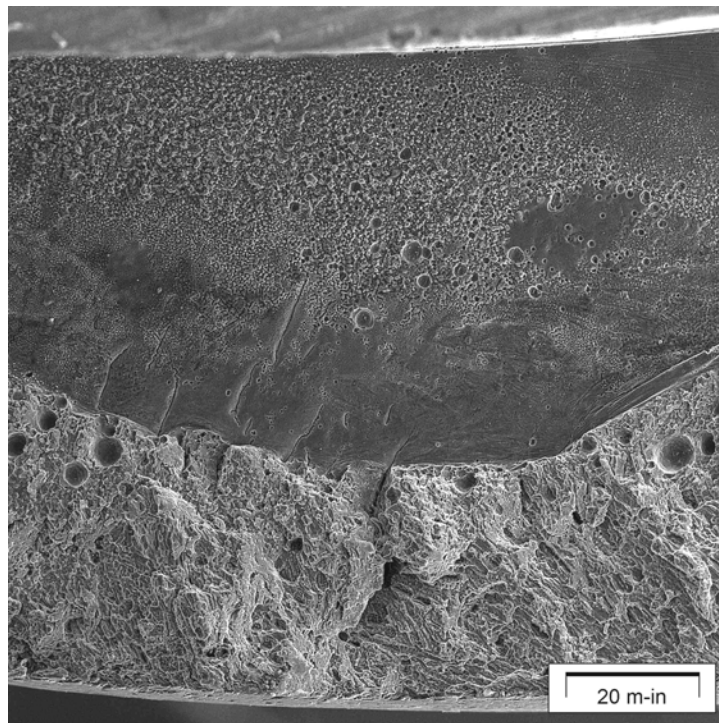
Figure 28. SEM fractograph showing fracture origin from figure 16.

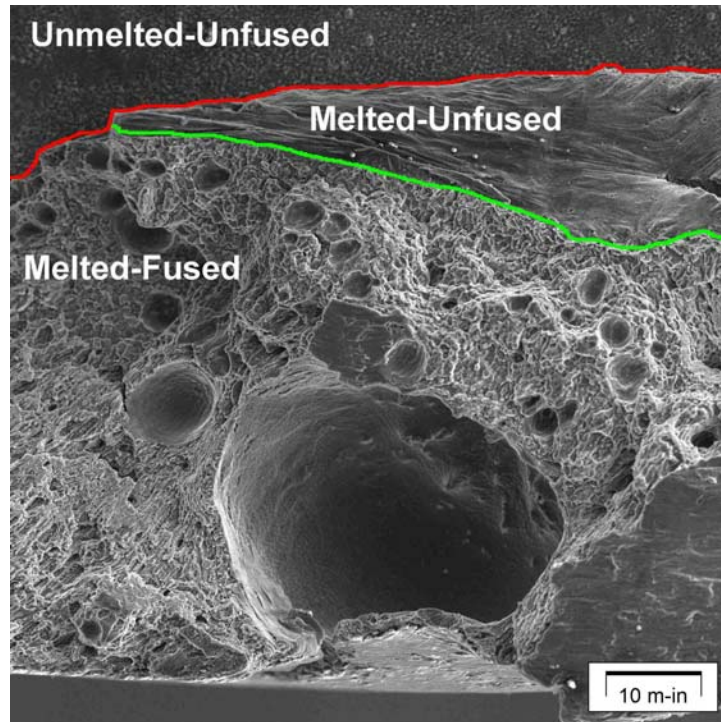
Scanning electron micrographs of the three fracture origins discussed earlier can be observed in figures 26–28 and at higher magnification in figures 29–31. Figure 29 presents the large gas void in greater detail. Due to the inherent gap between the tube and the elbow prior to welding, and the lack of full penetration, there existed areas where the tube material was melted but not

Figure 29. SEM fractograph showing unfused material from figure 26.

fused to the elbow. The melted and fused material left a discernible fracture surface where the parts were separated. This phenomenon can be observed in figure 29. Numerous large gas voids were observed at various locations on the fracture surfaces (figure 32 and 33).

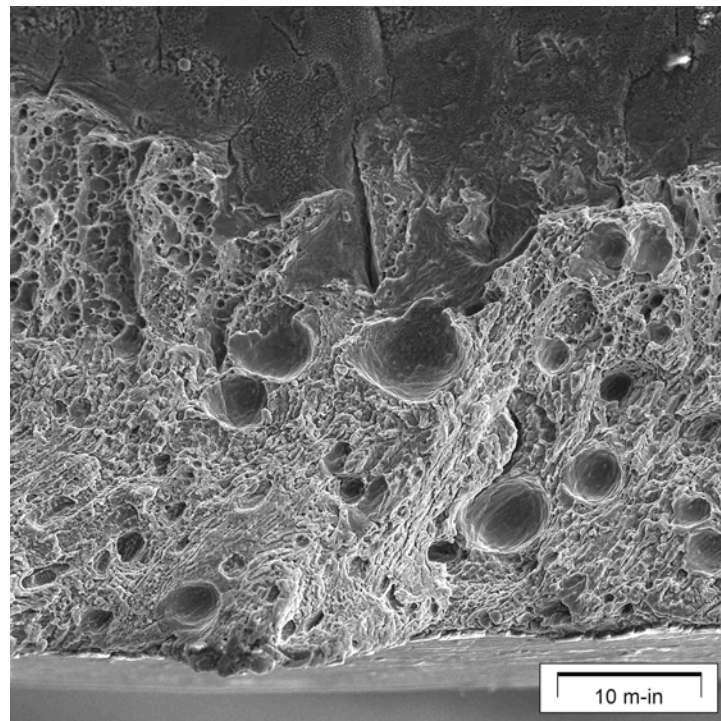
Figure 30. SEM fractograph showing enlargement of figure 27.

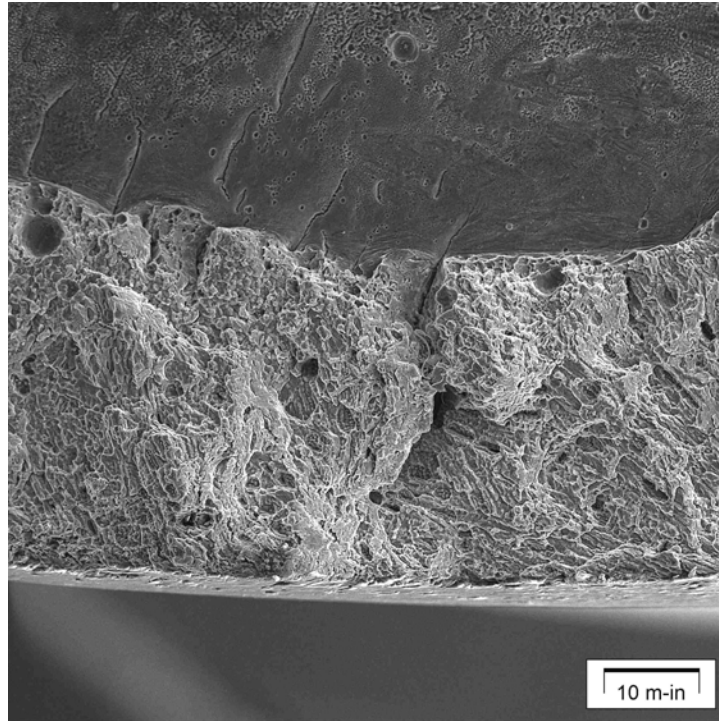
Figure 31. SEM fractograph showing enlargement of figure 28.

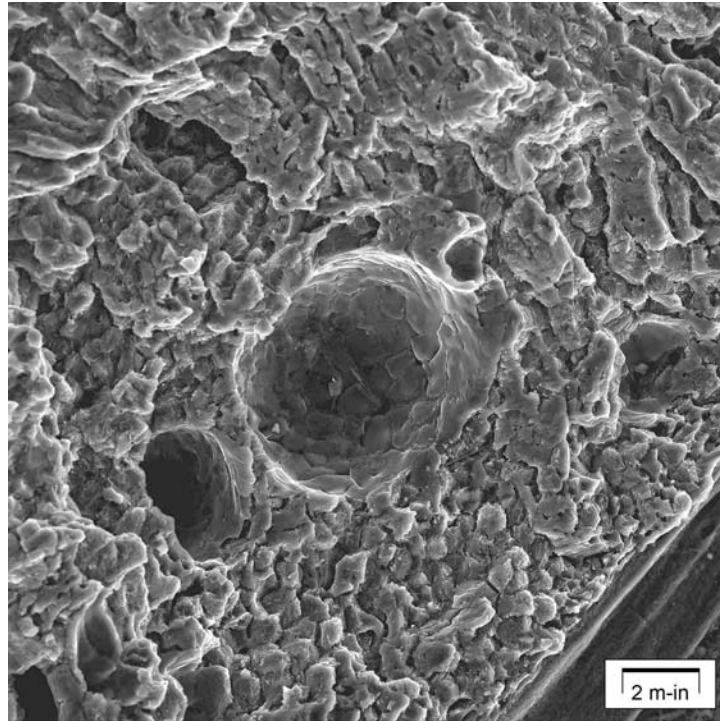
Figure 32. SEM fractograph showing typical gas voids on the surface.

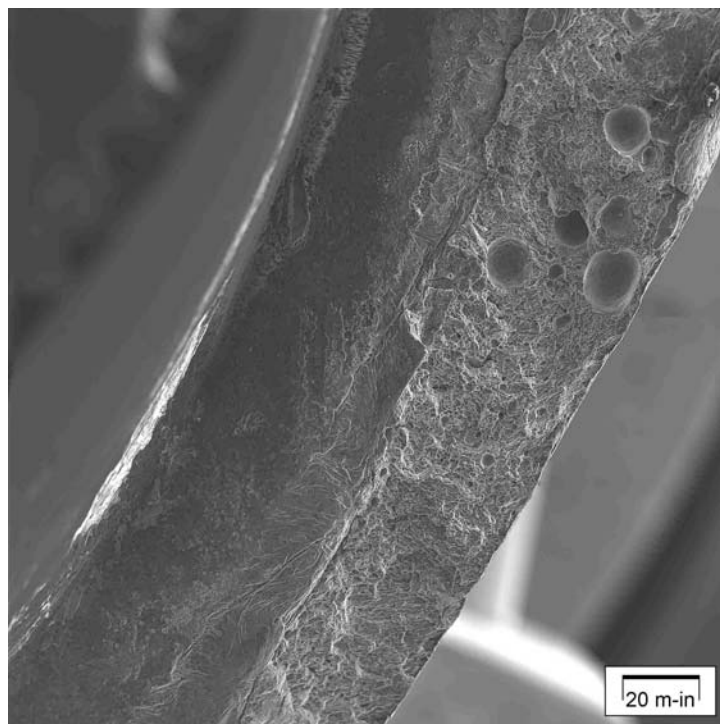
Figure 33. SEM fractograph showing additional typical gas voids on the surface.
